# AN OPERATIONS SOLUTION TO HEAVY HYDROCARBON PERMEATION IN GAS PIPELINES

A JANA White Paper

September 2021

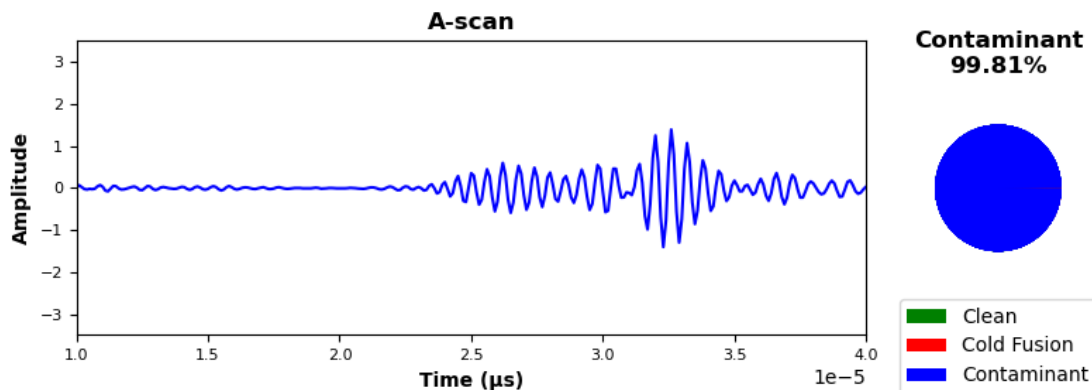
The Waveform Image is a .png file that captures the exact waveform which was shown on the screen when the ultrasonic measurement was saved, along with its class breakdown pie chart.

The A-Scan Data is a .csv file that includes the following Data:

- Session Metadata in JSON format
- Class Result (i.e., clean, contaminant, cold fusion, etc.) and numerical scores for each Class
- A-scan Time Series, including time and wave

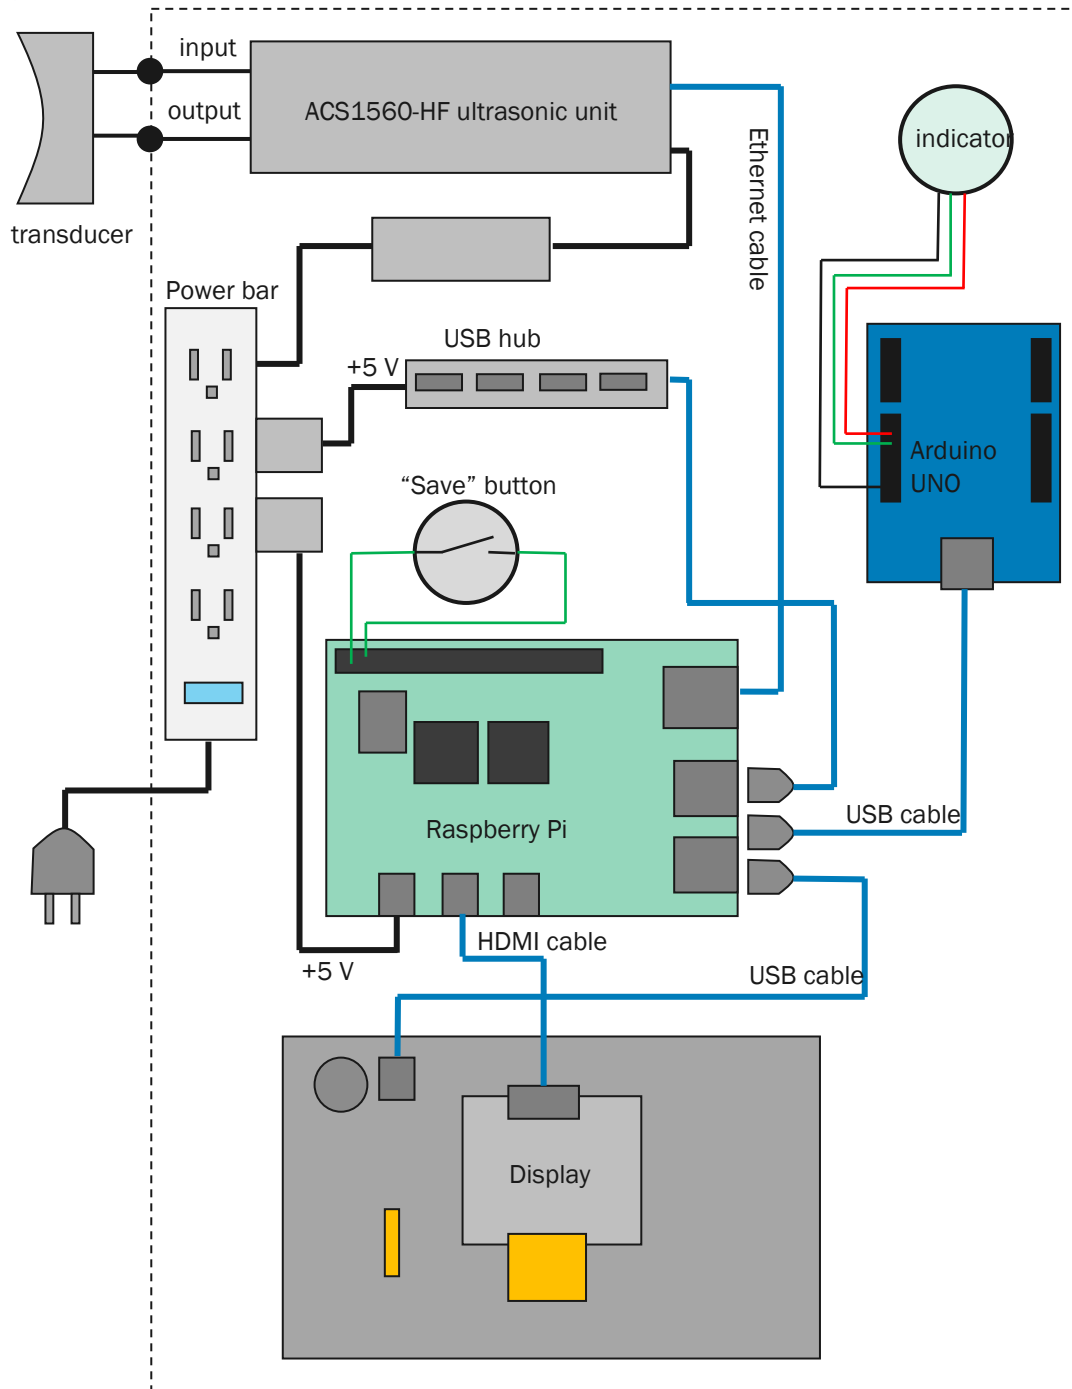
Figure A2: jaNaDeTect Components

The jaNaDeTect technology is based on A-scan ultrasonic analysis coupled with a spectral analysis algorithm. The hardware consists of the following as a minimum spec (specifics may be altered to address supply disruptions associated with the COVID pandemic):

- ACS 1560 HF ultrasonic unit with power supply
- Raspberry Pi 4 with power supply
- 7" HDMI Display with touchscreen DFR0506
- Arduino UNO
- USB hub with power supply
- Power strip with switch and surge protector
- Pushbutton
- Two-color indicator light
- Ethernet cable
- Cable HDMI - microHDMI
- Cable USB A male - USB miniB
- Cable USB A male - USB B male
- Two LEMO 00 through panel couplers
- Two LEMO 00 - LEMO 00 RF cables
- Plastic carrying case

jaNaDeTect includes a high-frequency A1560-SONIC-HF ultrasonic unit. Data digitized through an ethernet connection are transferred into a Raspberry Pi 4 computer for processing and storage. Estimation of joint quality is done by AI algorithm using the Arduino platform.

For butt fusion joints, the transducer itself is a special custom design through transmission where the wedge is enclosed and a pulser receiver is placed on one side. The receiver and emitter have 1.8 MHz frequency.

For electrofusion joints, the transducer utilizes the pulse/eco method with 0.25" diameter and 2.25 MHz frequency.
